# Description of Advanced Adjustments

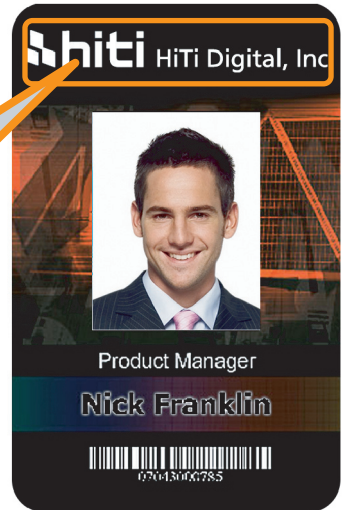
## Question 1

When YMC Feather-type Wrinkle appears in these areas (front or back side)

YMC Feather-type wrinkle may be caused by motor speed is too fast in supply side. Ribbon tension can be changed by adjusting motor speed. By doing so, it keeps the motor speed correctly in supply side during printing.

Slow down the motor speed on supply side (new ribbon)

In this case, it is suggested to reduce the value by 2~3 units when applying method #2

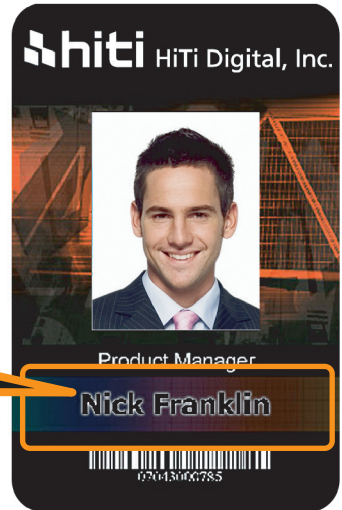
## ? Question 2

When water ripple appears in these areas (front or back side)

Water ripple may be caused by motor speed is too fast in supply side. Ribbon tension can be changed by adjusting motor speed. By doing so, it keeps the motor speed correctly in supply side during printing.

Slow down the motor speed on supply side (new ribbon)

In this case, it is suggested to reduce the value by 2~3 units when applying method #2

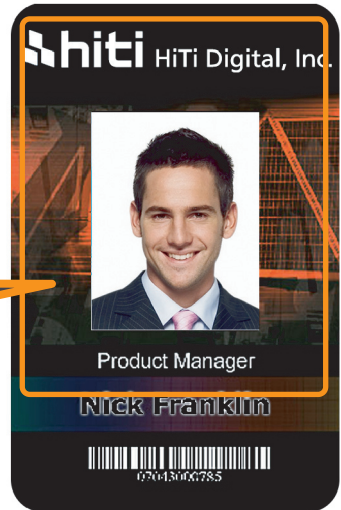
## ? Question 3

When stripes appears in these areas  
(front or back side)

Stripes may be caused by motor speed is too slow in supply side or motor speed is too fast in taken side. Ribbon tension can be changed by adjusting motor speed. By doing so, it keeps the motor speed correctly in supply side or taken side during printing.

Increase the motor speed in supply side or slow down the motor speed in taken side

In this case, it is suggested to increase the value by 2~3 units when applying method #2 or reduce the value by 1~2 units when applying method #1.

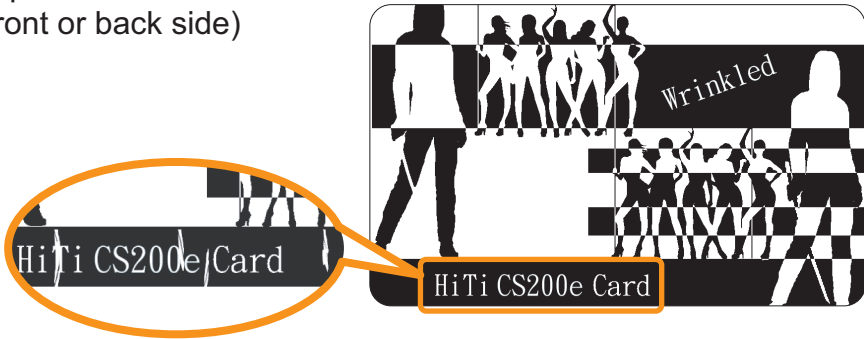
## ? Question 4

When Resin K Wrinkle appears in these areas (front or back side)

Resin K Wrinkle may be caused by motor speed is too fast in supply side. Ribbon tension can be changed by adjusting motor speed. By doing so, it keeps the motor speed correctly in supply side during printing.

Slow down the motor speed on supply side (new ribbon)

In this case, it is suggested to reduce the value by 2~3 units when applying method #2
