# Description of Advanced Adjustments

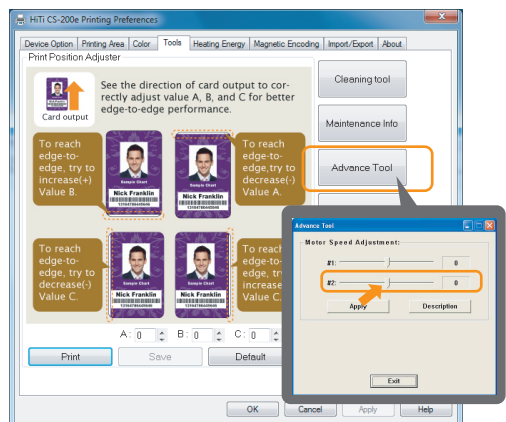
YMC Feather-type wrinkle may be caused by motor speed is too fast in supply side. Ribbon tension can be changed by adjusting motor speed. By doing so, it keeps the motor speed correctly in supply side during printing.

In this case, it is suggested to reduce the value by 2~3 units when applying method #2

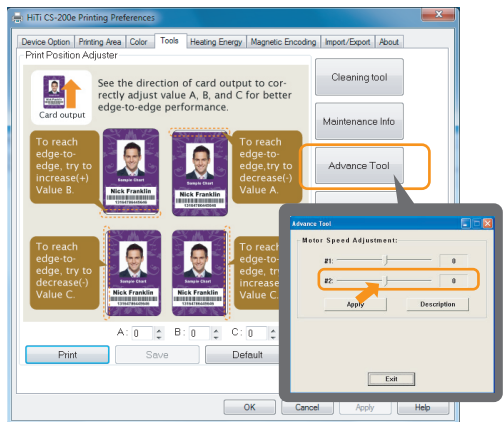
Water ripple may be caused by motor speed is too fast in supply side. Ribbon tension can be changed by adjusting motor speed. By doing so, it keeps the motor speed correctly in supply side during printing.

In this case, it is suggested to reduce the value by 2~3 units when applying method #2

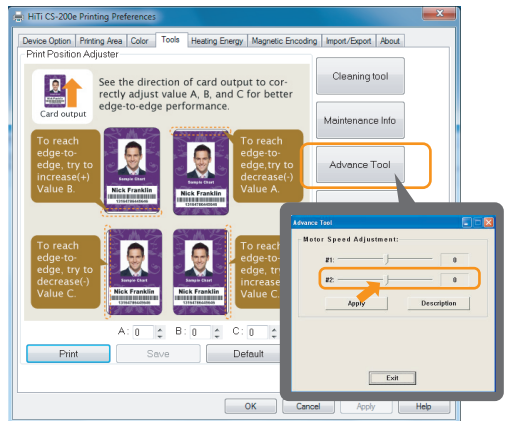
Stripes may be caused by motor speed is too slow in supply side or motor speed is too fast in taken side. Ribbon tension can be changed by adjusting motor speed. By doing so, it keeps the motor speed correctly in supply side or taken side during printing.

In this case, it is suggested to increase the value by 2~3 units when applying method #2 or reduce the value by 1~2 units when applying method #1.

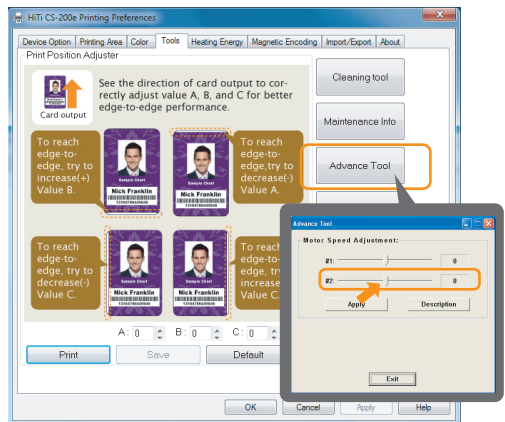
Resin K Wrinkle may be caused by motor speed is too fast in supply side. Ribbon tension can be changed by adjusting motor speed. By doing so, it keeps the motor speed correctly in supply side during printing.

In this case, it is suggested to reduce the value by 2~3 units when applying method #2

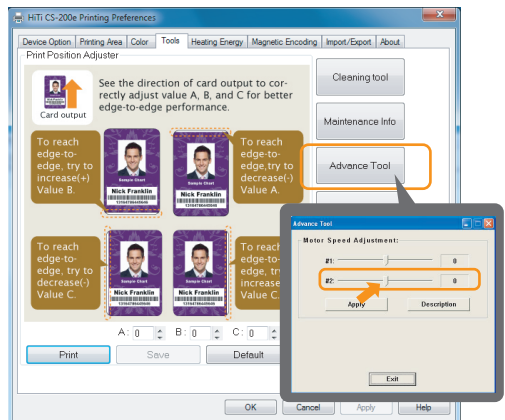
Resin K Wrinkle may be caused by motor speed is too slow in taken side. Ribbon tension can be changed by adjusting motor speed. By doing so, it keeps the motor speed correctly in taken side during printing.

In this case, it is suggested to up 2~3 units of the value when applying method #1
